Installation Instructions

24xLink – 24/1x Signal Kit

24^{LT}XLINK

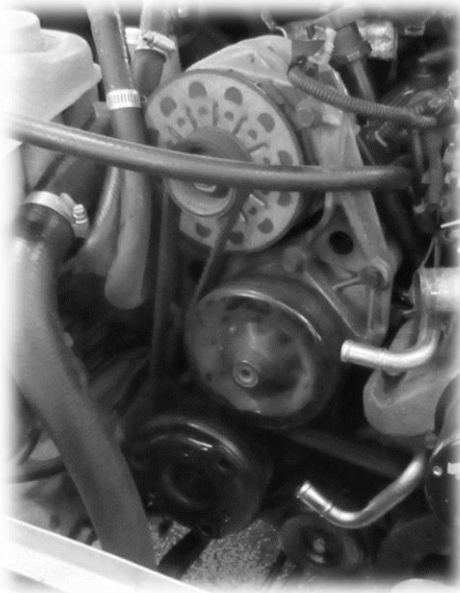
Figure 5 – Heater core hoses removed

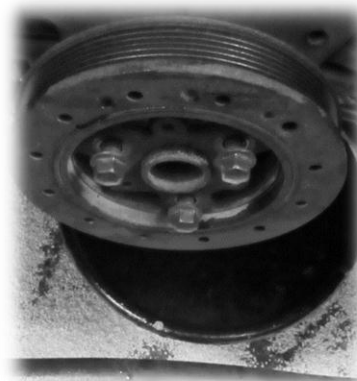
6. Remove the serpentine drive belt by rotating the spring loaded idler pulley. Use caution as this pulley is spring loaded. Once the belt is removed the idler pulley will settle beyond its usual position.
7. Remove the three bolts that hold the crank pulley to the crank hub. (Fig. 6). Remove the pulley from the crank hub.

Figure 6 – Crank pulley bolts being removed

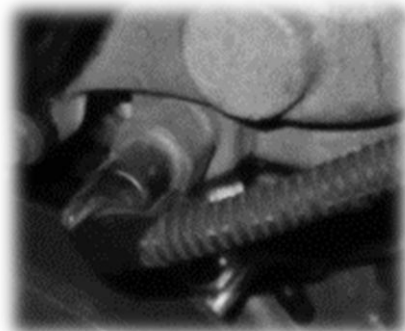
8. Disconnect the water pump ECT sensor connector. (Fig 7)

Figure 7 – ECT sensor connector

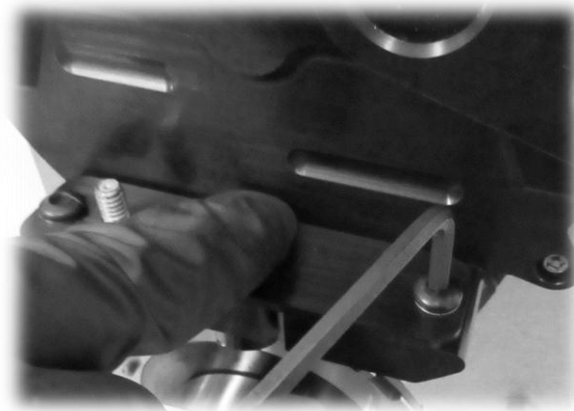
Figure 20

9. While the alignment tool remains in place tighten the crank sensor mount adjustment screws. Figure 20. The crank sensor mount is now properly centered over the 24x reluctor. Only if you do a complete teardown of the engine, should you ever have to re-do this adjustment. DO NOT lose the tool, it may need to be used in the future.
