# Installation Instructions

24xLink – 24/1x Signal Kit

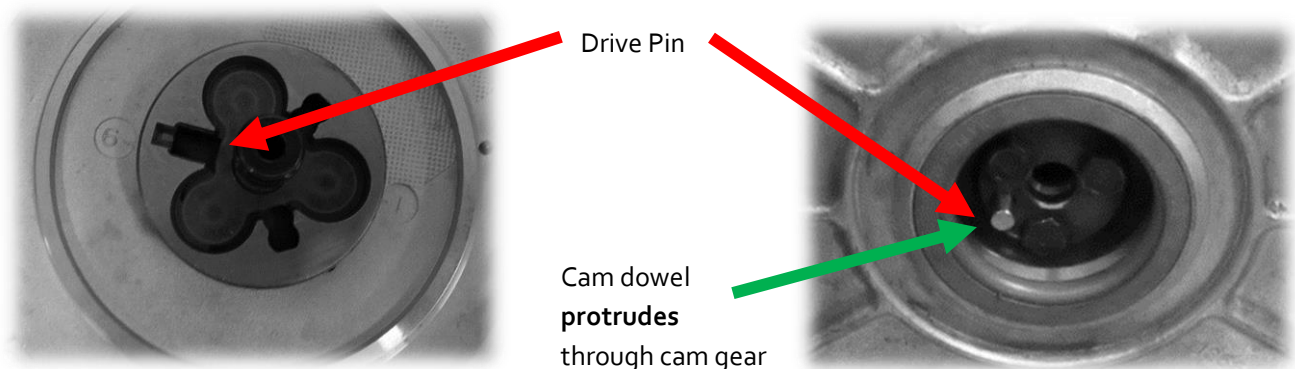
The later LT engine Optisparks were driven via an extended camshaft timing gear dowel pin. The camshaft dowel pin is longer than the camshaft dowel pin on early year engines and protruded into the Optispark pin drive spindle. This pin drive ensures the later Optisparks only installed in one way and were properly oriented to engine position.

Figure 3 – Pin drive spindle. Has locating hole for cam dowel pin.

Figure 4 – Pin drive Optispark drive dowel pin.

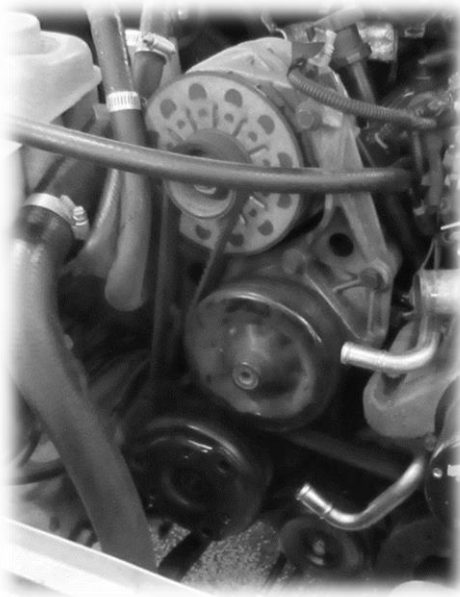
Figure 5 – Heater core hoses removed

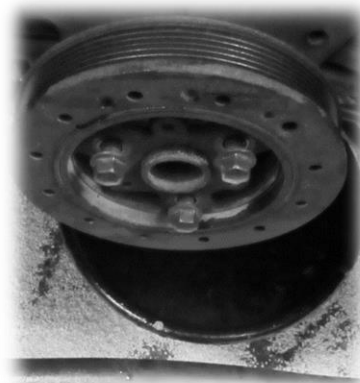
6. Remove the serpentine drive belt by rotating the spring loaded idler pulley. Use caution as this pulley is spring loaded. Once the belt is removed the idler pulley will settle beyond its usual position.
7. Remove the three bolts that hold the crank pulley to the crank hub. (Fig. 6). Remove the pulley from the crank hub.

Figure 6 – Crank pulley bolts being removed

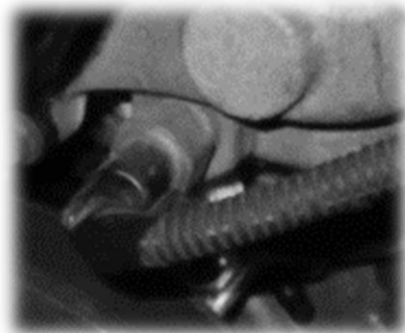
8. Disconnect the water pump ECT sensor connector. (Fig 7)

Figure 7 – ECT sensor connector

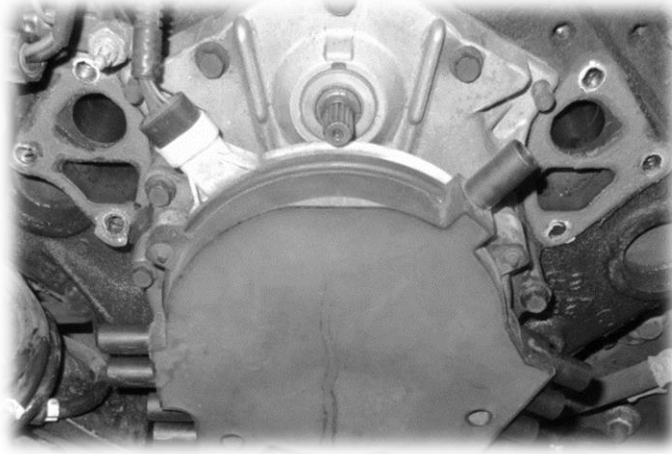
11. You should now be able to remove the water pump. It may need some nudging to knock it loose from the engine. Do not use hammer, or high force as you may crack the housing. Again be prepared for coolant to leak. (Fig 8)

Figure 8 – Water pump removed

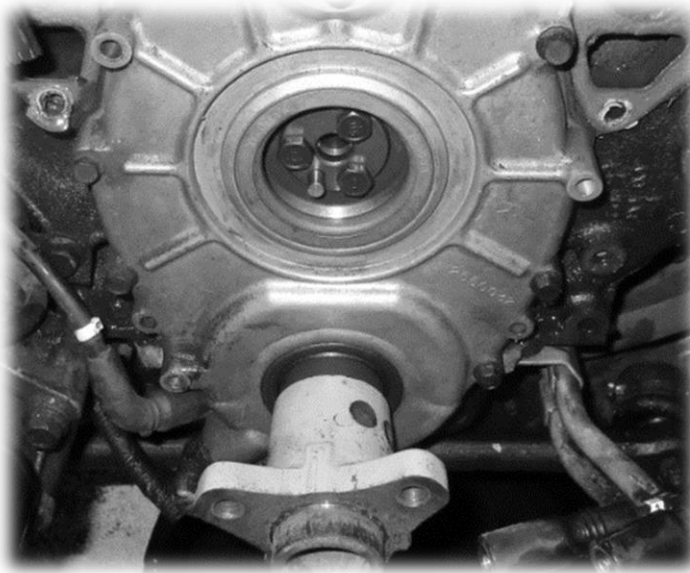
12. Complete access to the Optispark distributor is now complete. Disconnect the spark plug wires, coil wire, and distributor signal connector from the distributor. If equipped also disconnect the vacuum line from the distributor (late model Optisparks only).
13. Remove the three bolts that secure the Optispark distributor to the front timing cover of the engine. The Optispark can now be removed.

Figure 9 – Optispark Distributor removed. Late model type shown.

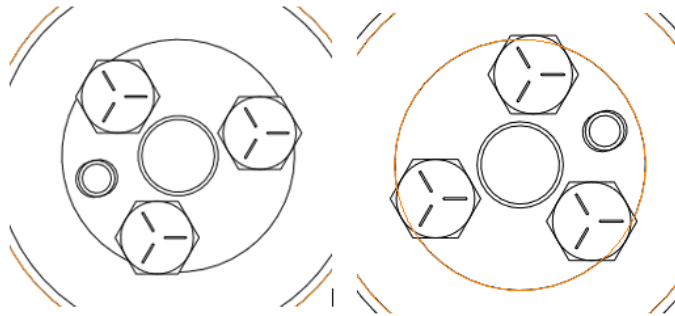
14. Rotate the engine so that the cam dowel pin is in either position (8 o'clock or 2 o'clock) shown in Figure 10. If your engine is the early type spline drive rotate the engine so that the spline drive index notch is in either the 5 o'clock or 11 o'clock position (You will have to use a light to peer through the spline drive hole in the front timing cover).

Figure 10 – Acceptable cam dowel positions when viewed straight on from front of engine. Viewable when using late model type pin drive.

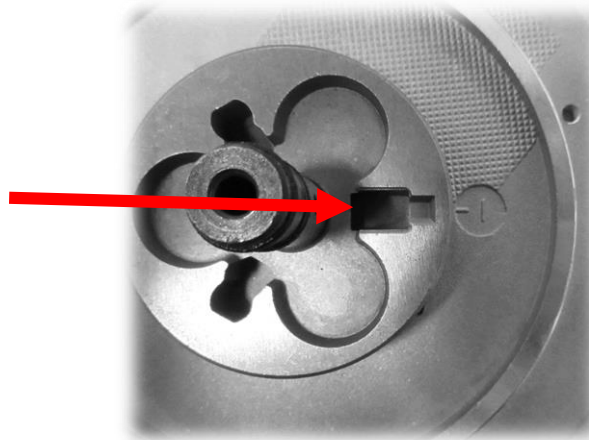
Pin Drive: Drive pin slot pointing at #1 indicator (Fig 11.)

Figure 11 – Pin drive slot pointing at #1 indicator marking.

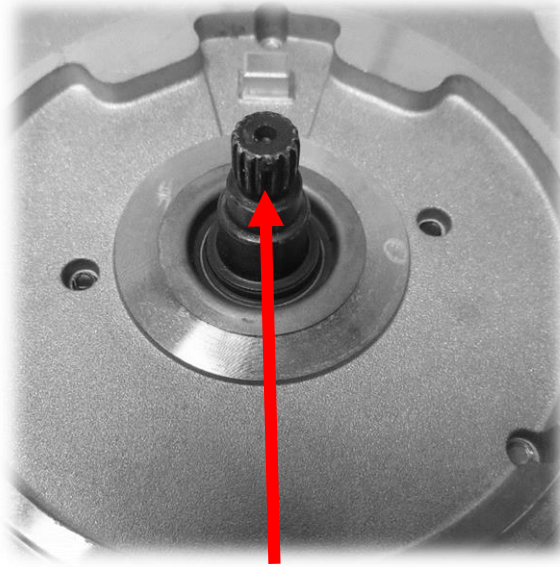
Spline Drive: Sensing unit drive tab in 6 o'clock position as shown in Figure 12

Figure 12 – Spline drive tab in 6 O'clock position.

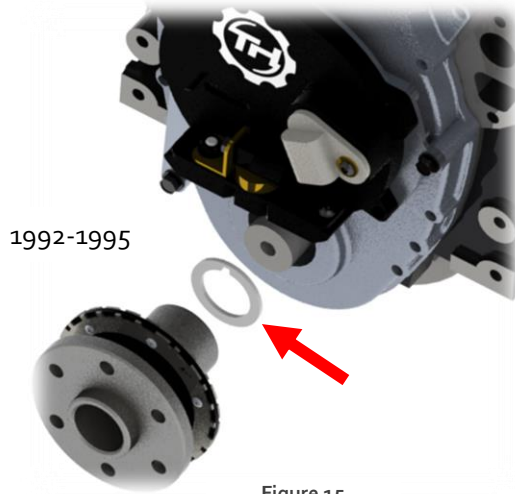
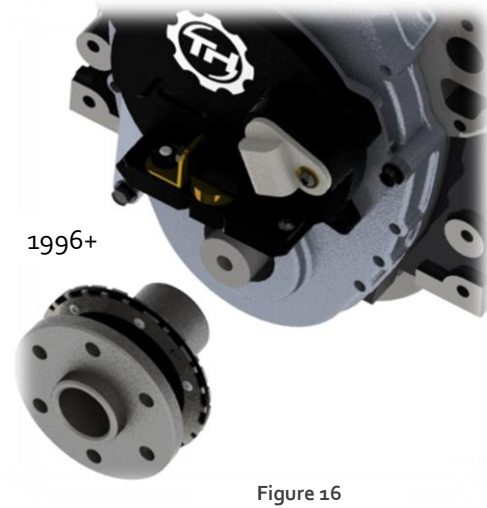
5. Install the TORQHEAD 24x crank hub, ensuring to align the crank hub keyway with the crankshaft key. Install the supplied crank hub spacer prior to installing the hub if your vehicle is a 1992-1995 vehicle (Fig 15). Do not use the supplied spacer if your vehicle is 1996+ (Fig 16). Note: This hub is a press fit onto the crank snout so it will need to be pulled on. **NEVER** use a hammer to drive it on.

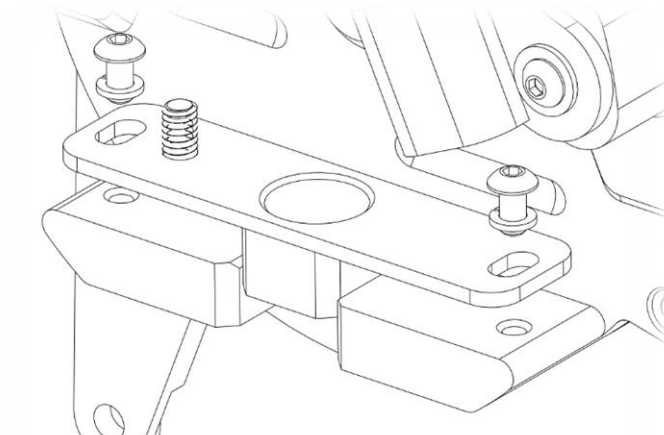
6. Install and torque the crank hub retaining bolt to manufacturer spec.
7. If not already performed, install the crank sensor mount onto the sensing unit. Two small 12-24 button head cap screws and serrated washers retain the crank sensor mount (Fig 17). Do not fully tighten the two screws, leave them loose enough that the crank sensor mount can slide back and forth.

| | Crank sensor mount adjusting screws are tight. | Loosen the crank sensor mount screws slightly so that the mount can slide back and forth while inserting the crank sensor alignment tool. If these screws are tight they will not allow the mount to center. |

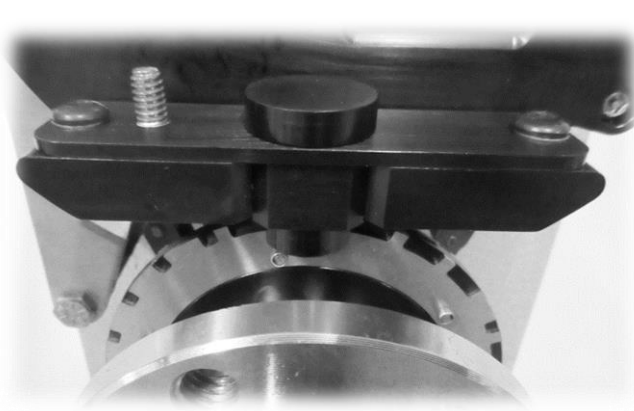
Figure 18

8. Insert the crank sensor alignment tool into the crank sensor mount. Once fully inserted this tool will setup the position of the crank sensor mount such that it, and the crank sensor, are centered over the 24x reluctor wheel. When inserting the tool ensure the slot/notch in the tool runs side to side and engages the 24x crank reluctor on the hub. Also ensure the tool is fully seated. See figures 18 and 19.

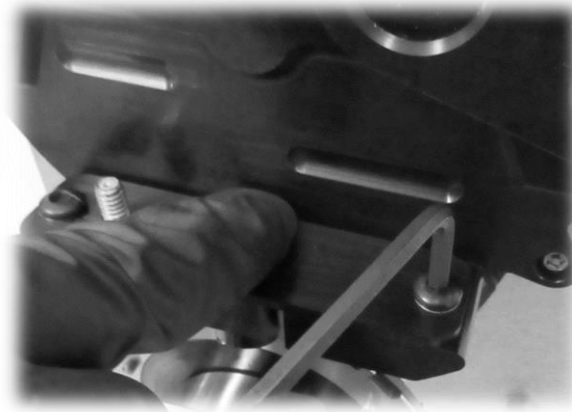
Figure 20

9. While the alignment tool remains in place tighten the crank sensor mount adjustment screws. Figure 20. The crank sensor mount is now properly centered over the 24x reluctor. Only if you do a complete teardown of the engine, should you ever have to re-do this adjustment. DO NOT lose the tool, it may need to be used in the future.

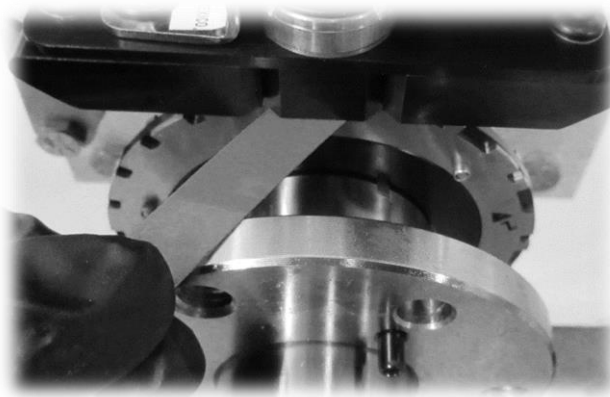
Figure 21

12. Dial in crank sensor air gap: Using the supplied yellow feeler gauge, test the crank sensor to reluctor air gap. Do this by trying to slide the yellow feeler gauge between the crank sensor and 24x reluctor as shown in Figure 21. Without any crank sensor adjustment shims installed (as per step 11) the yellow feeler gauge should not slide thru.

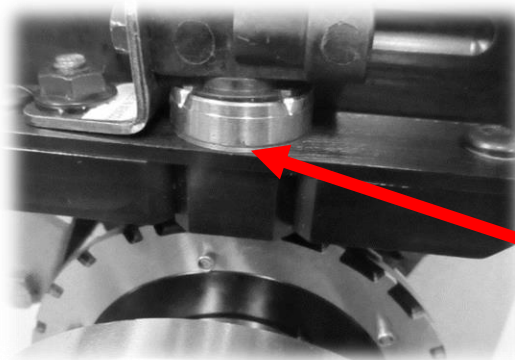
Figure 22

13. Remove the crank sensor and add one of the supplied round stainless shims under the crank sensor. Reinstall the crank sensor, ensure it seats fully and ensure to tighten the retaining nut down. See Figure 22.

Crank sensor  
adjustment  
Shim(s)

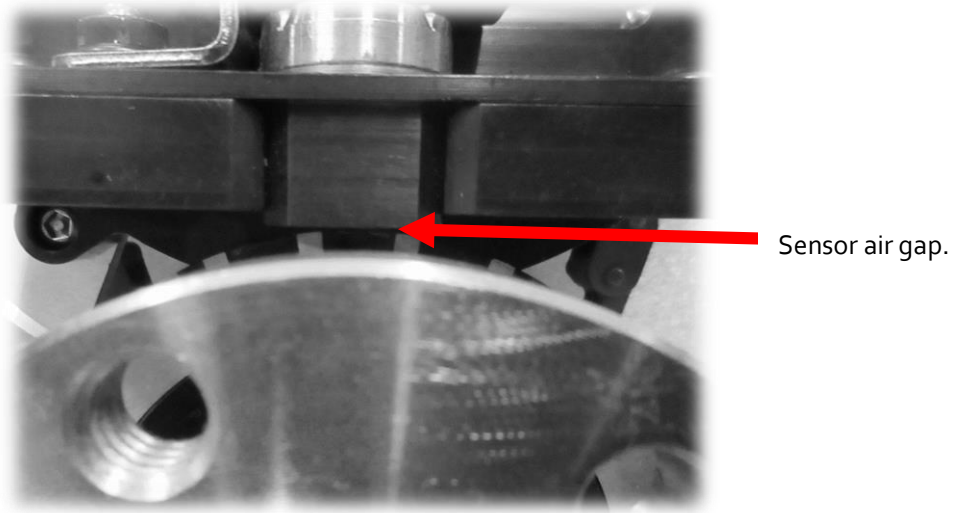
Figure 23

14. Test the air gap again with the yellow feeler gauge. If it passes through, even if slightly tight, that is OK the crank sensor air gap is now set (Figure 23). If it still does not pass through repeat step 13 & 14, adding one shim at a time, until the yellow feeler gauge passes through.
